**PRELIMINARY ASSESSMENT/
VISUAL SITE INSPECTION**

**KUNKLE FOUNDRY COMPANY, INC.
ANDREWS, INDIANA
IND 064 708 845**

FINAL REPORT

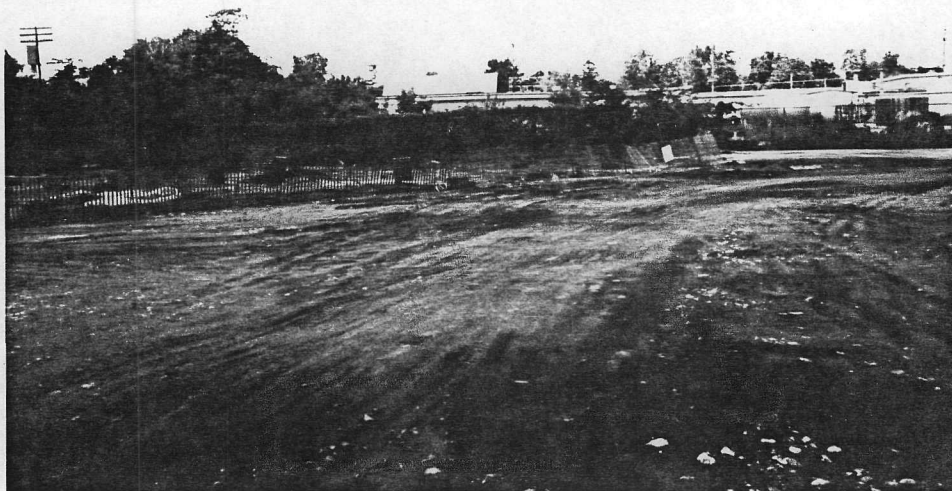
Photograph No. 1

Unit Description:	This unit was an outdoor sand pile located in the southwest corner of the facility. The unit is about an 80-foot radius quarter circle. The unit is currently fenced by a snow fence around the perimeter.
Date of Startup:	This unit began operation in about 1955.
Date of Closure:	This unit became inactive in 1988 and is currently undergoing closure.
Wastes Managed:	This unit stored waste foundry sand (D008) prior to off-site disposal.
Release Controls:	This unit had no release controls while in operation. Currently, there is a plastic cover over the area.
History of Documented Releases:	This unit has caused some lead contamination of soil immediately under and adjacent to it. The contamination is being addressed as part of the closure.
Observations:	During the VSI, this unit contained 55-gallon drums of soil cuttings on top of a plastic covering (see Photograph Nos. 1 and 2).

Description: This photograph shows the northern part of the Former Waste Sand Pile. The location is covered, fenced, and 55-gallon drums of soil cuttings are on top of the location.

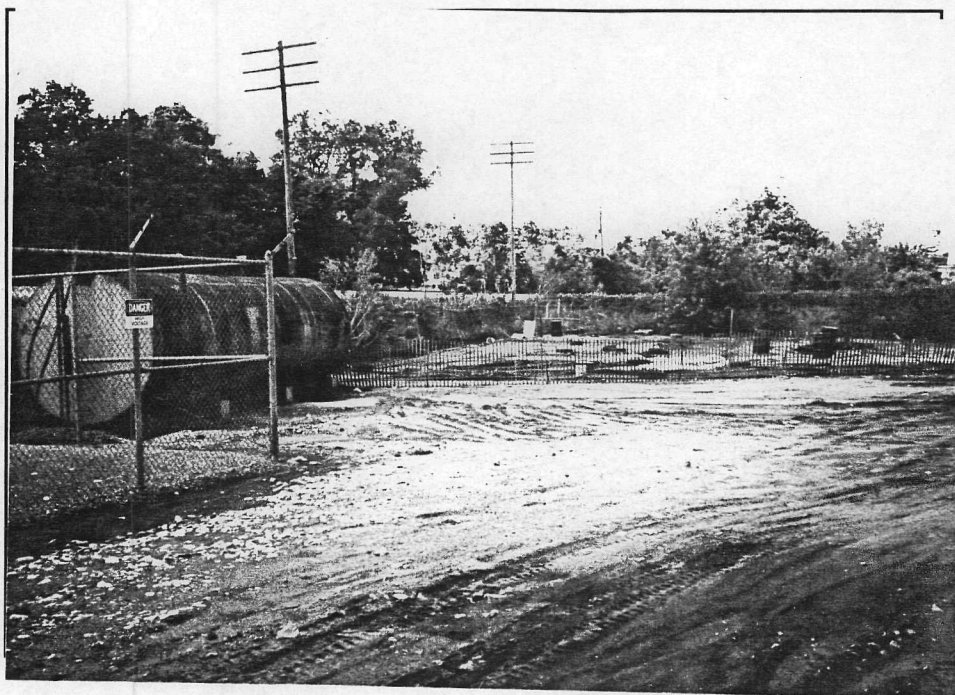
Photograph No. 2

Description: This photograph shows the southern part of the Former Waste Sand Pile. The aboveground storage tank formerly held oil, but is currently empty. Note that the aboveground tank is not resting on the ground.

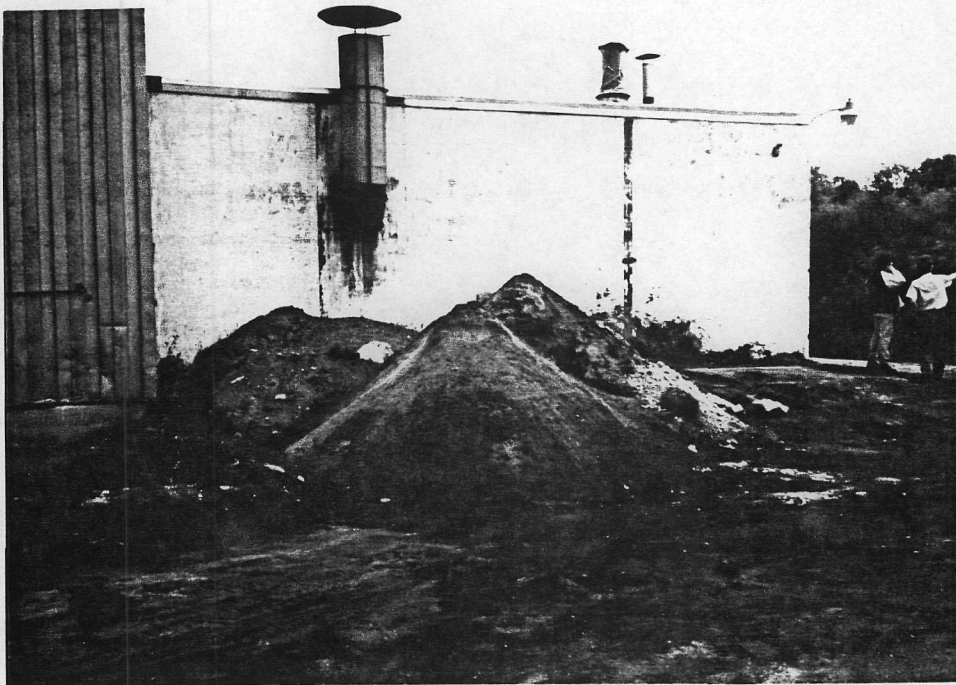
Photograph No. 3

Observations: During the VSI, this unit contained uncovered foundry sand piled approximately 4 to 5 feet high. PRC noted black foundry sand layered above the soil all around this SWMU (see Photograph No. 3).

Description: This photograph shows the Waste Sand Pile. Hazardous sand which has been stabilized and rendered nonhazardous as well as other sands are stored here prior to disposal. Concrete is the base for the back half of the pile, while soil is the base for the front half of the pile.

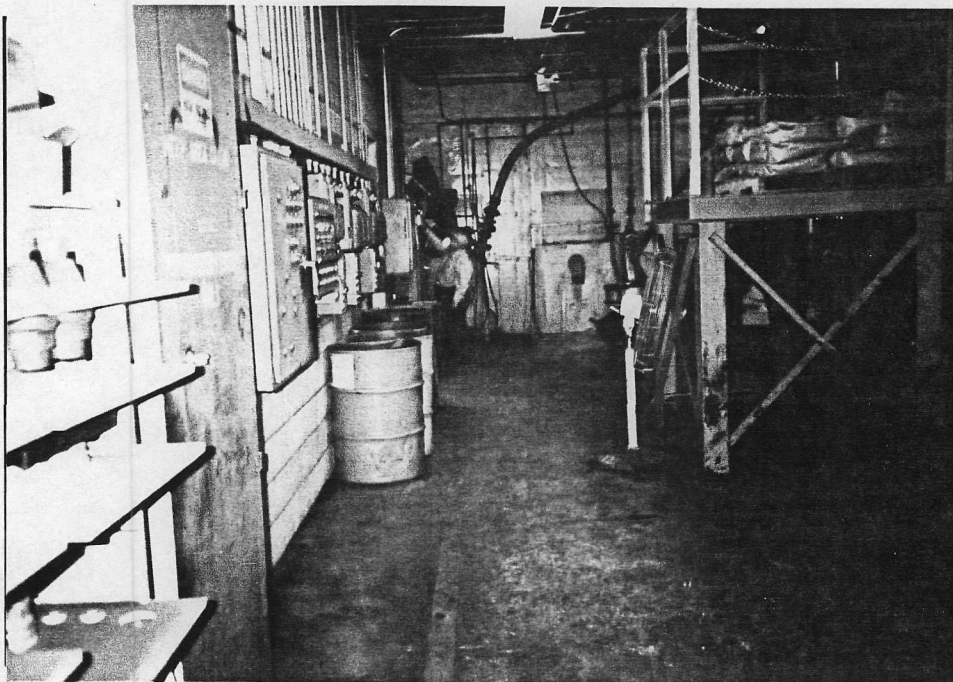
Photograph No. 4

Description: This photograph shows the Sand Storage Area in the Muller Room. The 55-gallon drum holds the muller scrap that is filtered from the sand. The metal and sand are reused while the unusable sand is disposed.

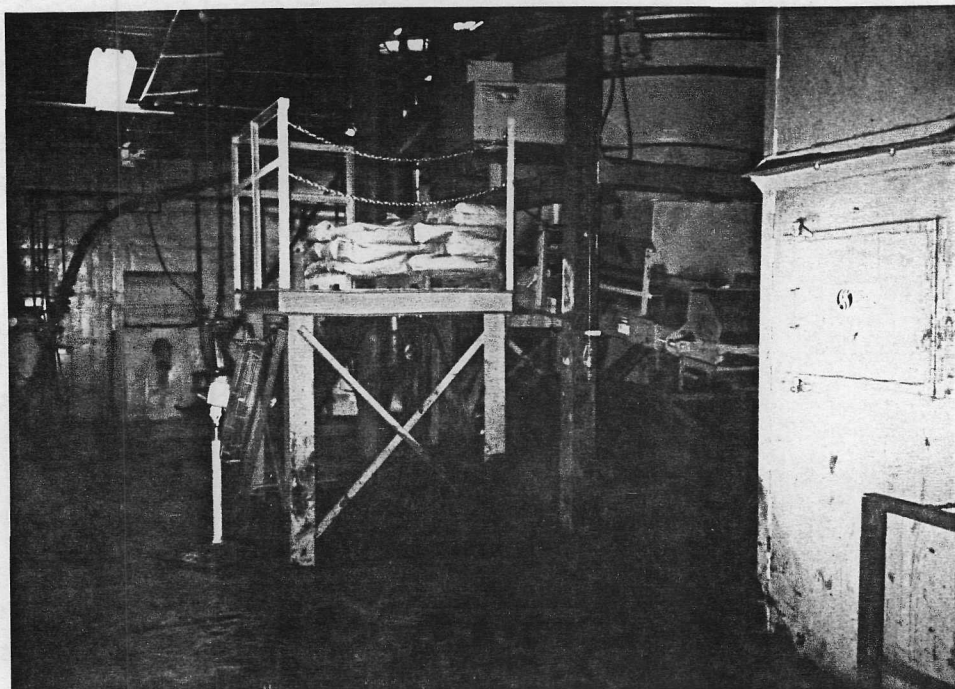
Photograph No. 5

Description: This photograph shows the Sand Storage Area in the Muller Room. The foundry sand shown is reused after being dried on the concrete floor.

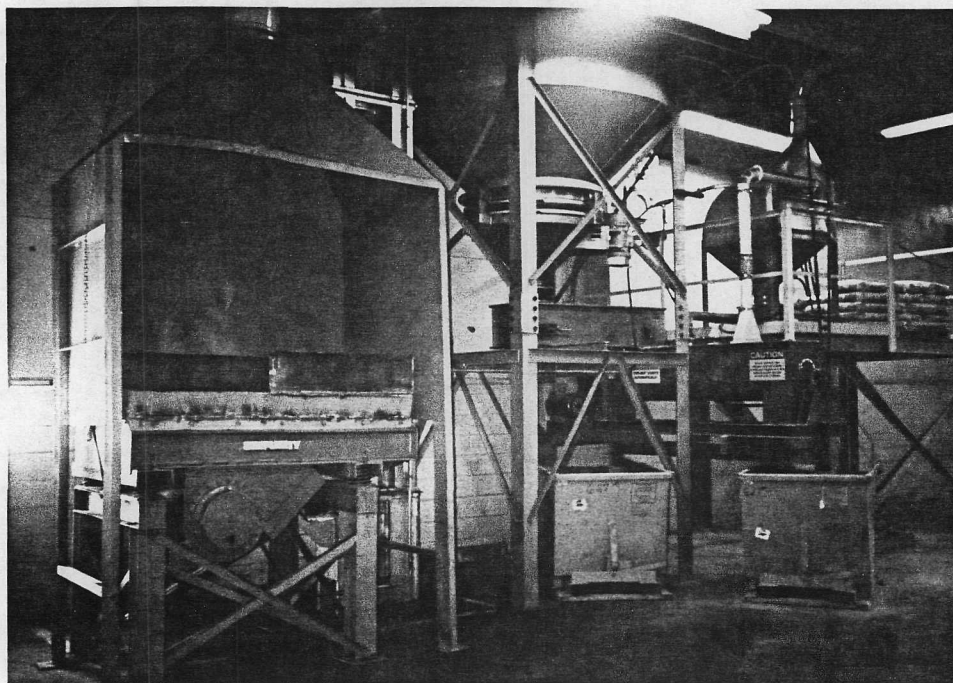
Photograph No. 6

Date of Startup:	The treatment unit began operation in February 1992. It went into full operation starting May 1992.
Date of Closure:	This unit is active.
Wastes Managed:	This unit treats waste sand (D008), core butts, waste crucibles, and waste furnace refractory (D008) prepared in the ball mill. Ball mill dust (D008) and waste foundry sands (D008) are stabilized in an accumulation tank with the addition of portland cement to form nonhazardous foundry sand waste. This unit will also manage contaminated soil (D008) that will be remediated next year in the closure of the Former Waste Sand Pile (SWMU 1).
Release Controls:	This unit is located indoors and on a concrete floor. No floor drains are located in the area of this SWMU.
History of Documented Releases:	No releases from this unit have been documented.
Observations:	This unit was not operating during the VSI. PRC noted no evidence of release (see Photograph Nos. 6, 7, and 11).

Description: This photograph shows the Sand Treatment Unit.

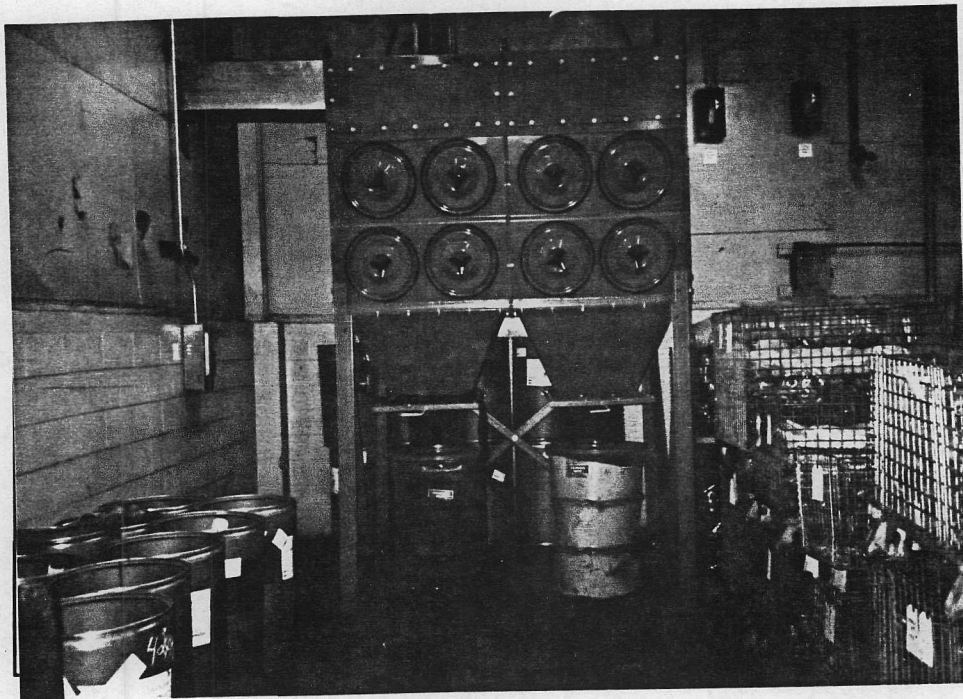
Photograph No. 7

Description: This photograph shows two 55-gallon drums being prepared for return to the Sand Treatment Unit (SWMU 4). The blue unit collects the dust from the Sand Treatment Unit. Drum storage for isocure scrub waste is shown in the front of the photograph.

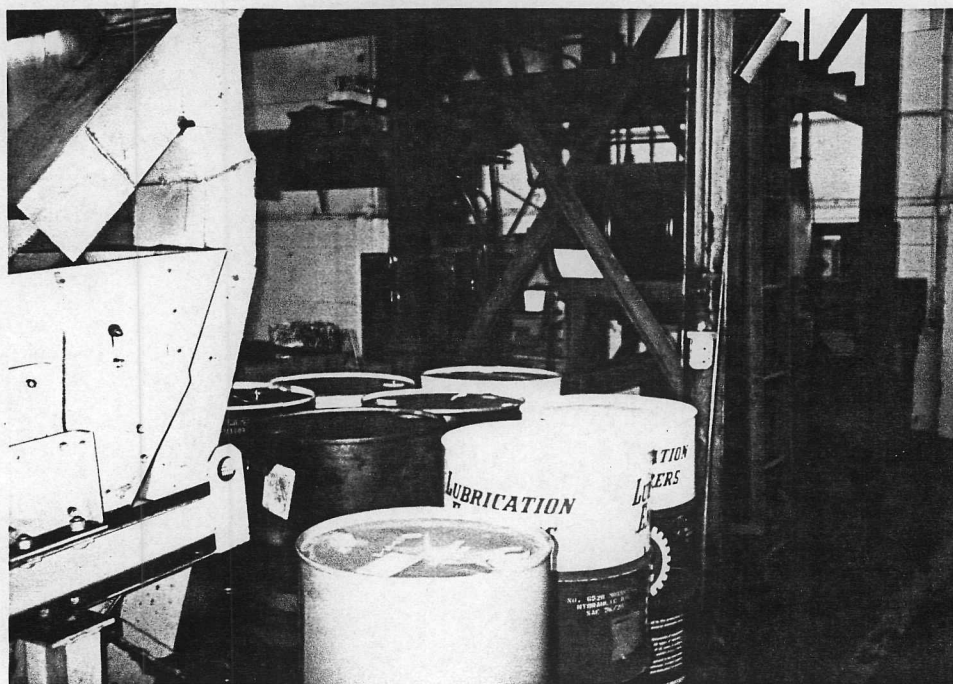
Photograph No. 8

Observations: During the VSI, the unit contained five drums of oil binders, two empty drums, and one drum of compressor oil. PRC noted no evidence of release (see Photograph No. 8).

Description: This photograph shows 55-gallon drums of old binders that for which the facility has no use. These drums are located next to the old air set line. Five drums contain old binders, one contains compressor oil, and two are empty.

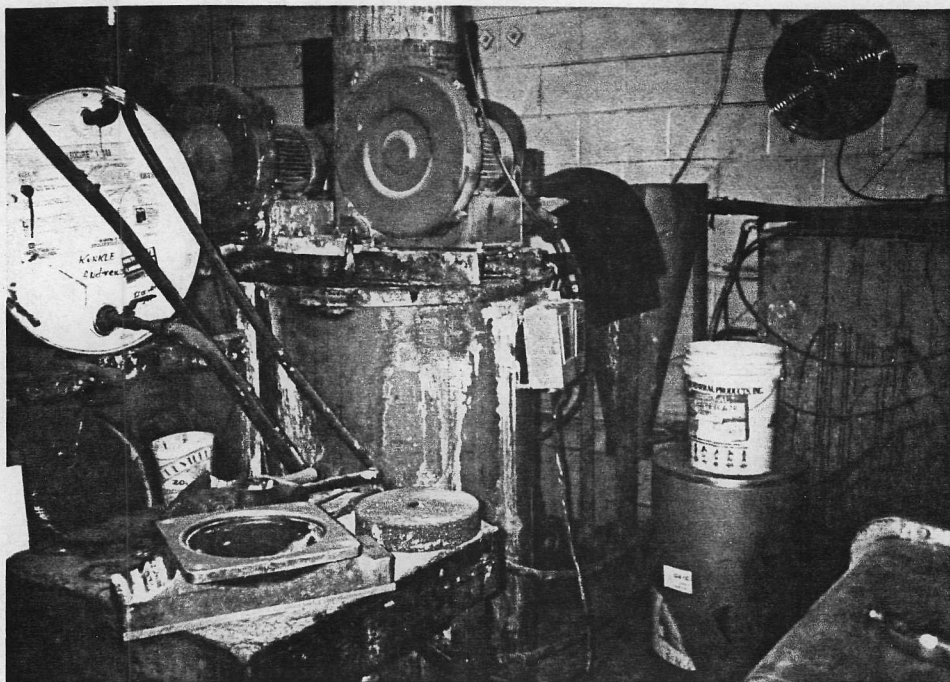
Photograph No. 9

Description: This photograph shows the isocure scrubber unit. Cleanout from this unit goes to the Isocure Scrubber Waste Storage Area in front of dust unit from Sand Treatment Unit (SWMU 4) (see Photograph No. 7).

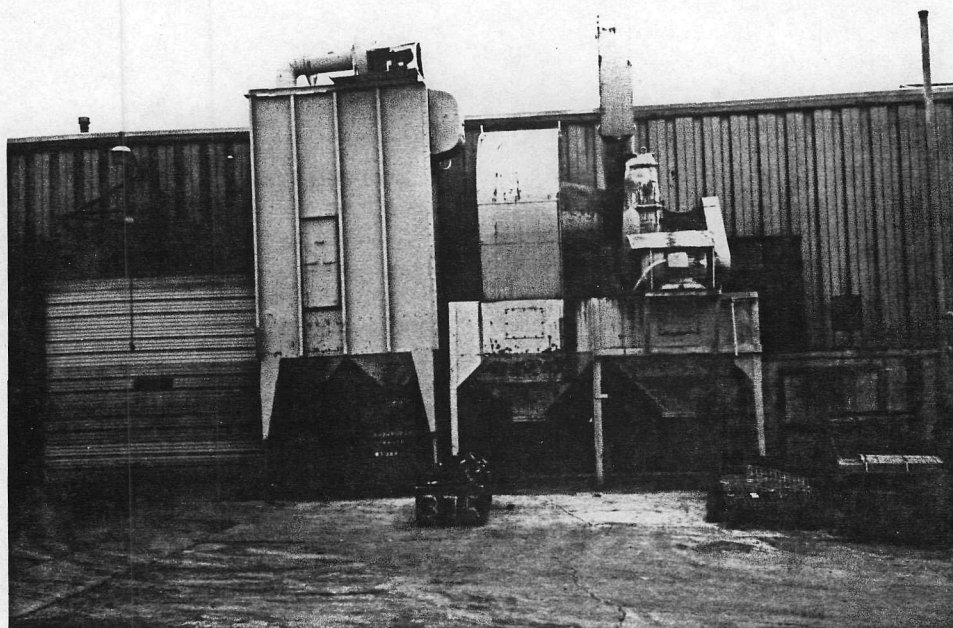
Photograph No. 10

Description: This photograph shows the wheelabrator waste being collected in two bed hoppers. The two units on the right collect brass grindings that are reclaimed.

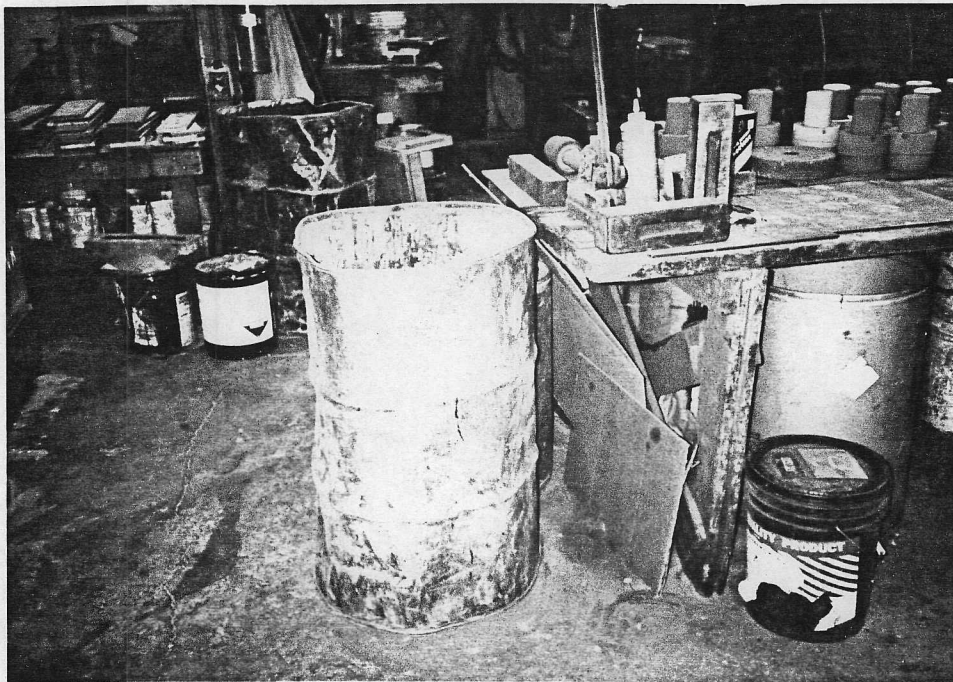
Photograph No. 12

Observations: During the VSI, this unit contained a 55-gallon drum about one-third full of core waste. PRC noted no evidence of release (see Photograph No. 12).

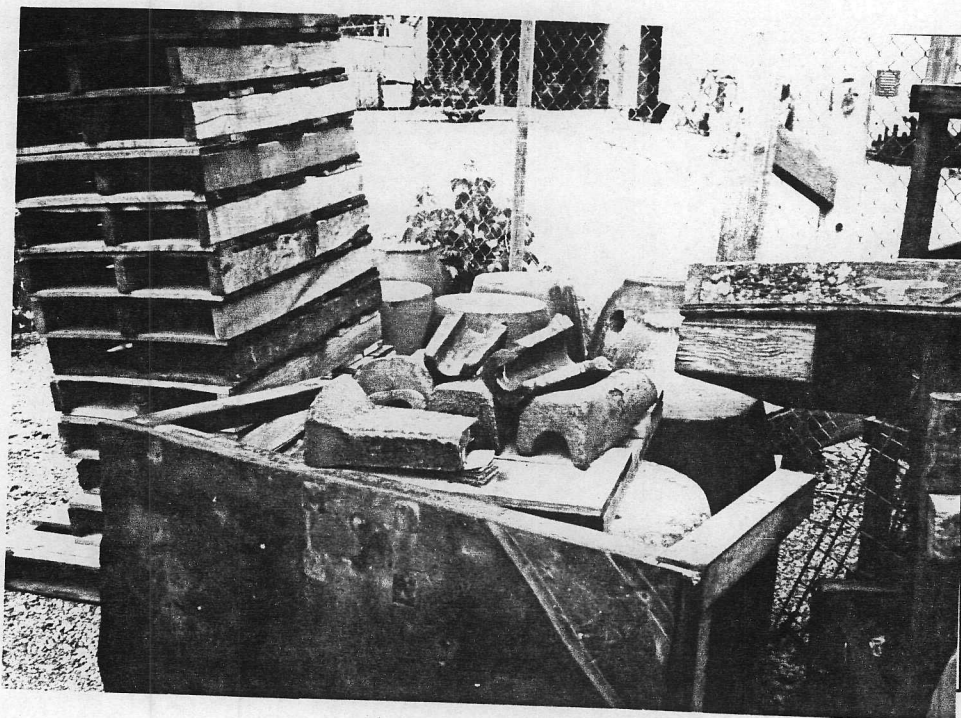
Photograph No. 13

Observations: During the VSI, the unit contained approximately ten large crucibles and six broken smaller pieces located on wooden skids. PRC noted no evidence of release (see Photograph No. 13).

Description: This photograph shows old crucibles that have been stored outside for an undetermined amount of time.

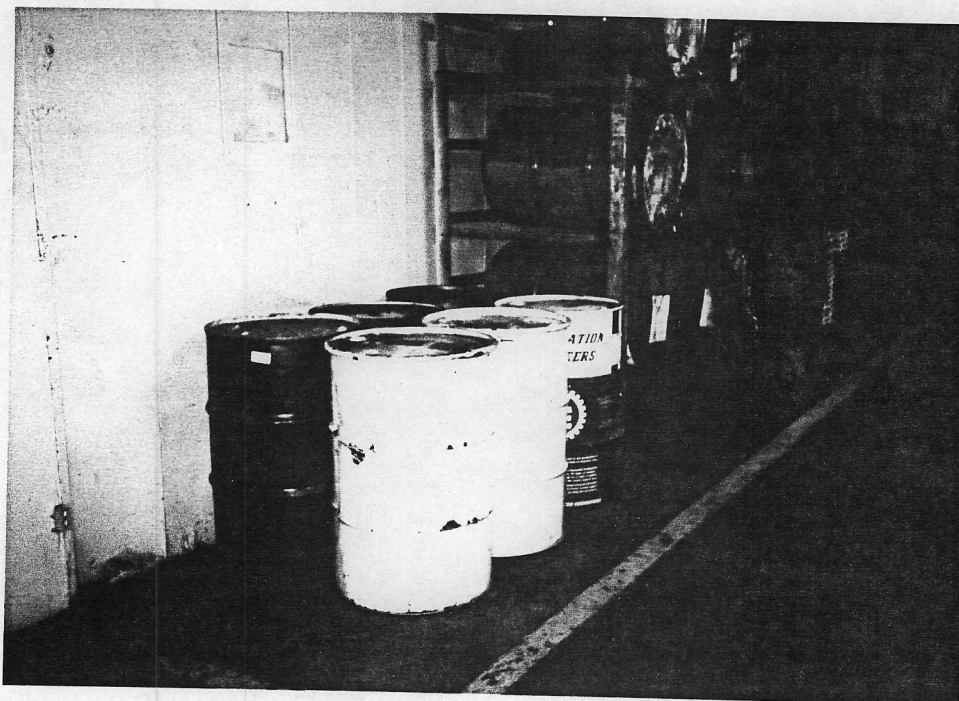
Photograph No. 14

Description: This photograph shows the Used Oil Storage Area. Six drums of used oil are located here next to product oil.

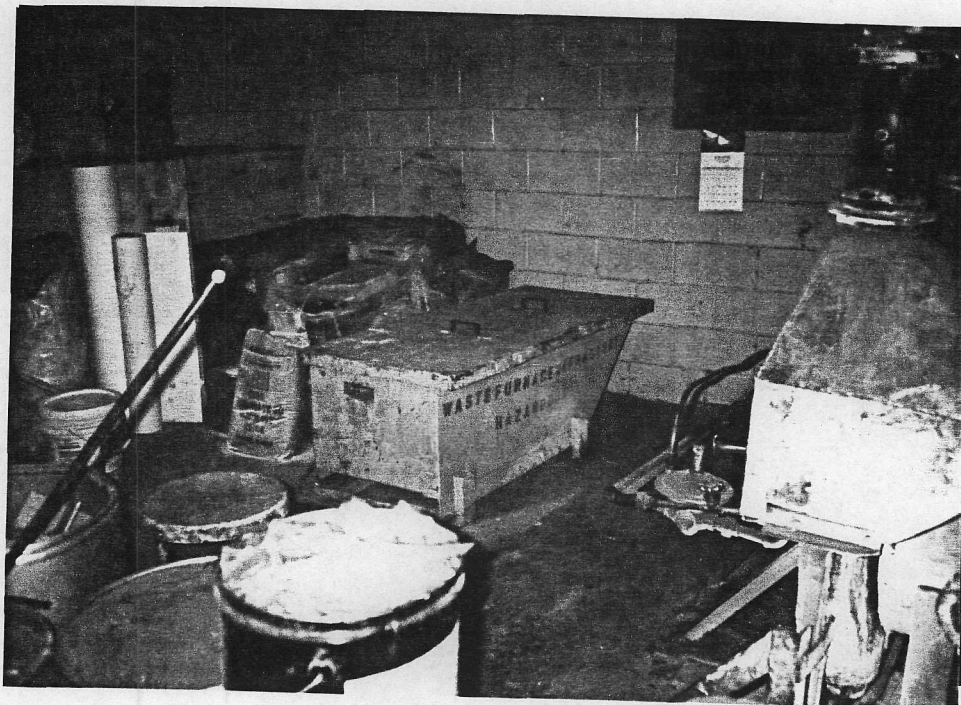
Photograph No. 15

History of Documented Releases:	No releases from this unit have been documented.
Observations:	The unit contained a covered refractory waste hopper during the VSI. PRC noted no evidence of release (see Photograph Nos. 15 and 16).
